STOPS FORMICARY CORROSION IN ITS TRACKS

The Nortek Global HVAC line of Anteater MC[®] Micro-Channel evaporator coils eliminates leaks caused by formicary corrosion. These products are ideally suited for climates and environments where formicary corrosion is an ongoing problem.

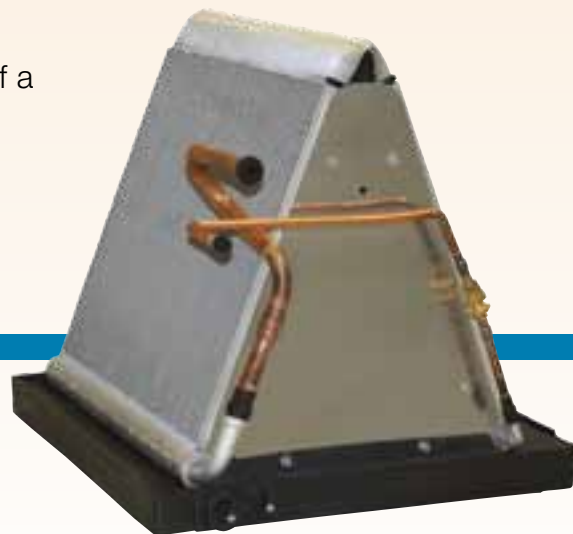
Anteater MC coils feature an all-aluminum Micro-Channel construction. This coil design provides water management and thermal performance results equal to the standard copper tube-in-fin designs, except with superior resistance to formicary corrosion and galvanic corrosion. Benefits include:

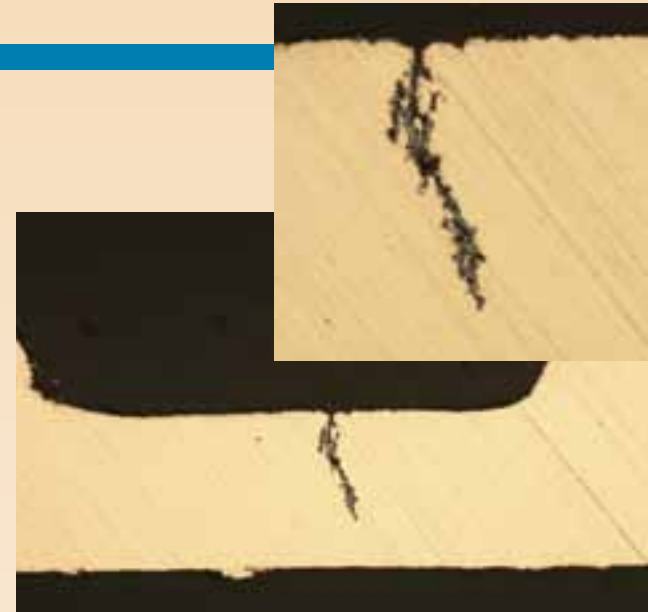
C12200 Alloy sample 100X & 200X magnified, unetched formicary field failure

As the major cause of indoor coil leaks, formicary corrosion occurs in copper-based alloys and is comprised of small, wandering pits that are not observable to the unaided eye. The tunneling effect that occurs to the copper material is similar to tunnels formed in an ant's nest. "Formicary" literally means "ant's nest."

Acid – Environmental contaminants such as household particles collect on the copper tubing and mix with the moisture. This forms an organic acid that begins to eat away at the copper. The acid creates a tunneling effect similar to that of ant tunnels, penetrating the copper completely and creating the leak.

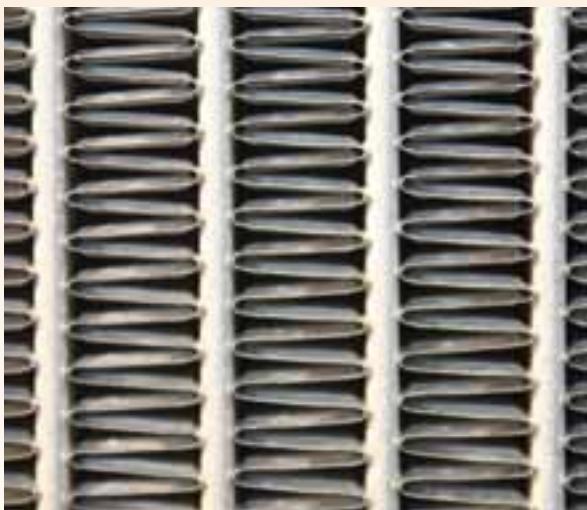
Anteater MC Micro-Channel coils are constructed of aluminum extruded tubes that are brazed to enhanced aluminum fins.

Because Anteater MC Micro-Channel coils are all aluminum, they eliminate the copper element in the formicary corrosion combination. Without copper, the corrosion process cannot happen.
